Mercedes W123 Over-voltage Protection Relay and Fuse Replacement

On the 1984 and 1985 California only models of the W123, and all of the 1985 "Federal" models, an over-voltage protection relay was added to protect several other new components. Learn to service the fuse on it, and replace it if it is faulty.

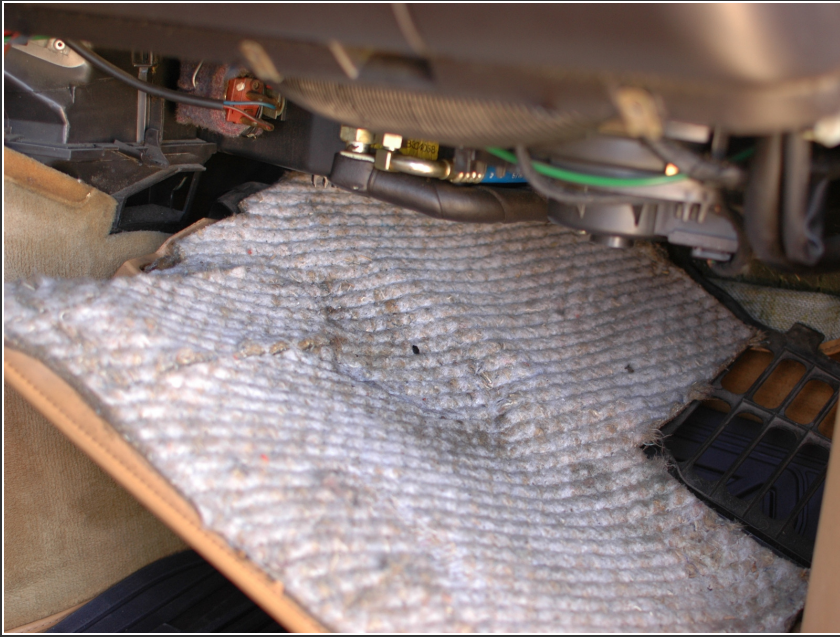
Step 1 — Over-voltage Protection Relay and Fuse

- To access the OVP relay you'll need to remove the passenger side kick panel. [See the guide on this process.](#)

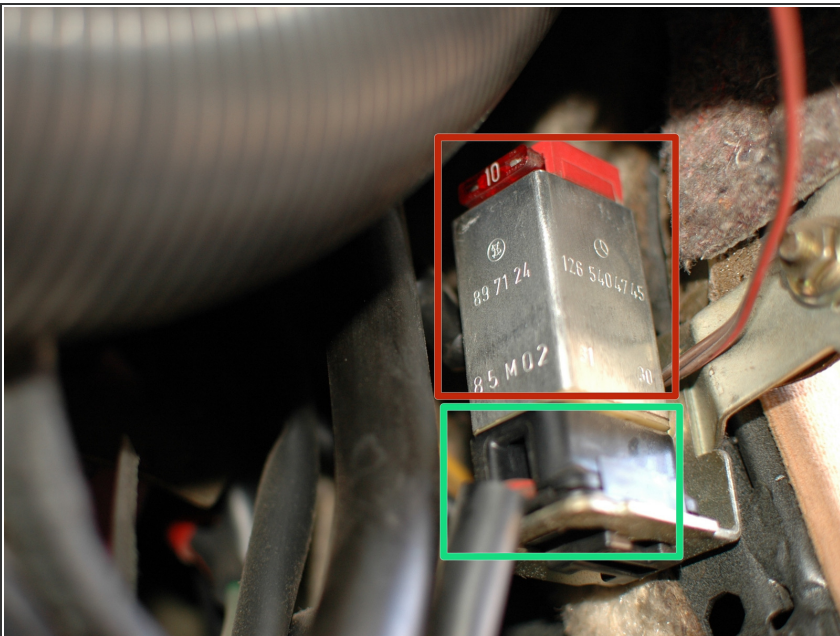
Step 2

- Look up inside below the dash, just beneath the furthest right side dash vent. You'll see the OVP relay with the red fuse on top.
- Even if you are just checking the fuse, the easiest way to get access is to remove the entire relay. Simply pull it up and off of the black plug it is attached to, which sits beneath it.

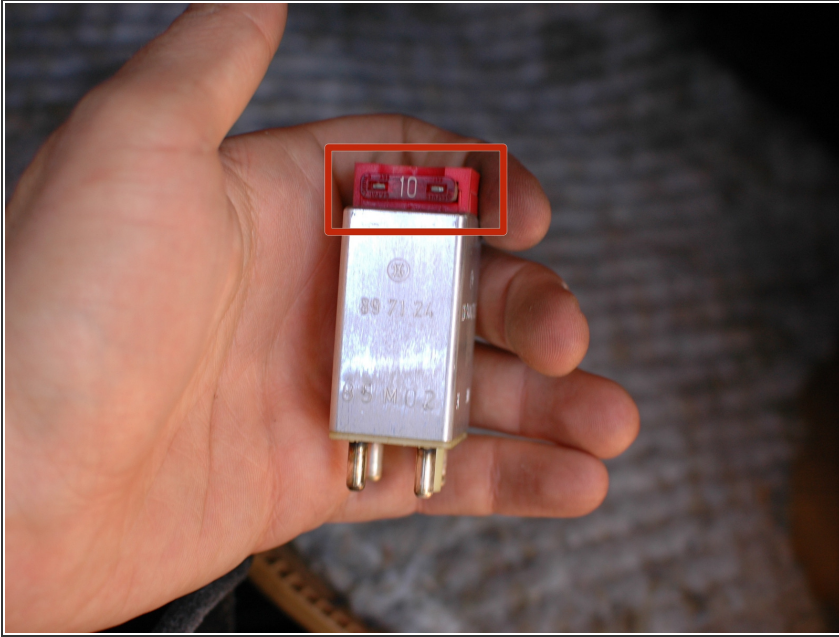
Step 3

- This is the OVP relay out from under the dash.
- The fuse on top slides in side-ways. It is a 10 amp fuse.
- You can use a needle nose pliers to pull the fuse out of the holder that is attached to the relay.

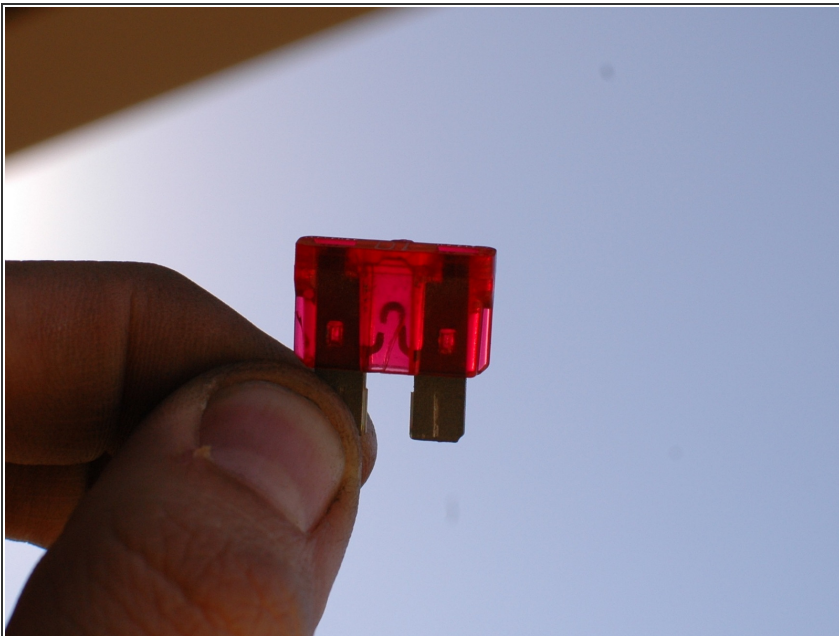
Step 4

- As you can see here, the fuse was blown. The filament is broken internally.
- Since this was the case, the fuse was replaced. The tachometer returned to normal function indicating that the fuse was the problem.
- If the fuse continues to blow, the OVP relay may need to be replaced. If the fuse is not blow, you may need to test and/or replace the OVP relay.
